DEPARTMENT OF TRANSPORTATION

Contract #: 04-0120F4Cty: SF/ALA Rte: 80 PM: 13.2/13.9File #: 69.28**WELDING INSPECTION REPORT****Resident Engineer:**Pursell, Gary**Address:** 333 Burma Road**City:** Oakland, CA 94607**Report No:** WIR-000136**Date Inspected:** 26-Apr-2007**Project Name:** SAS Superstructure**OSM Arrival Time:** 800**Prime Contractor:** American Bridge/Fluor Enterprises, a JV**OSM Departure Time:** 1730**Contractor:** Zhenhua Port Machinery Company, Ltd (ZPMC), Changxing Island **Location:** Shanghai, China**CWI Name:** Huang Wei**CWI Present:** Yes No**Inspected CWI report:** Yes No N/A**Rod Oven in Use:** Yes No N/A**Electrode to specification:** Yes No N/A**Weld Procedures Followed:** Yes No N/A**Qualified Welders:** Yes No N/A**Verified Joint Fit-up:** Yes No N/A**Approved Drawings:** Yes No N/A**Approved WPS:** Yes No N/A**Delayed / Cancelled:** Yes No N/A**Bridge No:** 34-0006**Component:** N/A**Summary of Items Observed:**

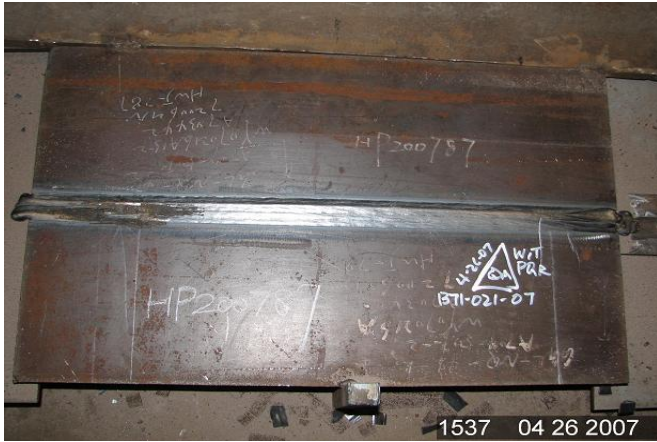
The QA inspector performed final visual examination to the test coupon after completion of the PQR-HP200787. The QA inspector observed that welds appeared to be in general compliance with the contract documents. The QA inspector assigned a lot # B71-021-07 on this date. The digital photograph below shows the PQR test coupon after completion.

After the completion of the test coupon, the QA inspector relayed to ABF representative Song Wemin that the weld at the left end of the test coupon had approximately 0.5 mm by 50 mm underfill and the rest of the weld had a maximum weld reinforcement of approximately 3 mm. The QA inspector recommended Mr. Song to grind even the weld reinforcement according with AWS D1.5 2002 section 5.26.1.1 for radiographic testing purpose. After consulting with ZPMC representatives, Mr. Song relayed to the QA inspector that if the radiograph film shows obscure areas that limited the interpretation, ZPMC would reject the test coupon PQR-HP200787.
